AIRCRAFT CONNECTOR BONDING RESISTANCE TESTS AND MATERIALS ANALYSIS

ABSTRACT

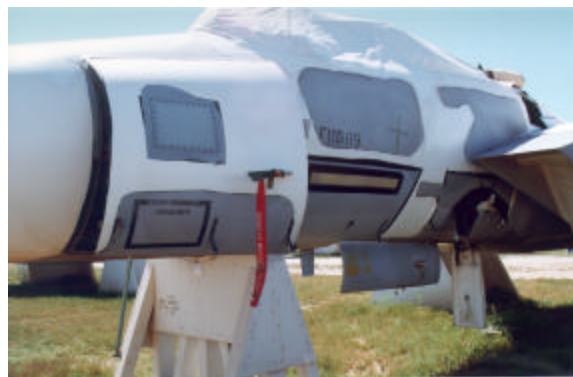
As part of an aging aircraft study, it was desired to measure the connector bonding resistance of connectors and their points of attachment that have been in place on aircraft over a long period of time. This was done to determine the effect of long-term usage and storage on the electrical bonding of connectors to components and aircraft structure members. Access was gained to two F-15s and one F-16 aircraft in storage at the Aerospace Maintenance and Regeneration Center (AMARC) at Davis-Monthan Air Force Base. The aircraft selected were largely intact and had been prepared for long-term storage in the desert. Figure 1 shows one of the aircraft selected, an F-15, with its armament bay cover unlatched.

Figure 1 F-15 at Davis-Monthan AFB

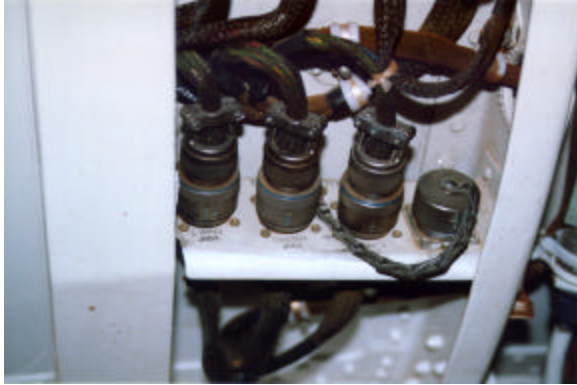
Tail numbers indicated the F-15 aircraft were manufactured in 1973 and 1976 and the F-16 was manufactured in 1982. The F-15s were stationed in Hawaii, and the F-16 was based in Florida. Access was gained to several areas of the interior of the aircraft through landing gear wells, access panels, etc. A variety of bulkhead connectors were accessed, as well as some connected to avionics. Most of the connectors were of circular configuration (figure 2).

Figure 2 Connectors inside F-15 aircraft

Resistance measurements were made between the connector shells and the bulkheads or avionics using the four-point probe system connected to a Keithley digital multimeter. Nine connector/bulkhead assemblies were measured on one F-15 aircraft, and four from another F-15. It was attempted to take measurements from connectors in approximately the same location on both aircraft. Eight connector/bulkhead assemblies and three connector/avionics assemblies were measured on an F-16 aircraft. Resistance measurements varied widely, and ranged from 3.0 milliohms on a connector mated to a bulkhead located inside a wheel well of an F-15 aircraft to 8400 milliohms (8.4 ohms) on a connector attached to a bulkhead located inside an F-15 aircraft underneath the cockpit. There appeared to be no correlation between bonding resistance measurements and the age or location of the connector on the aircraft.

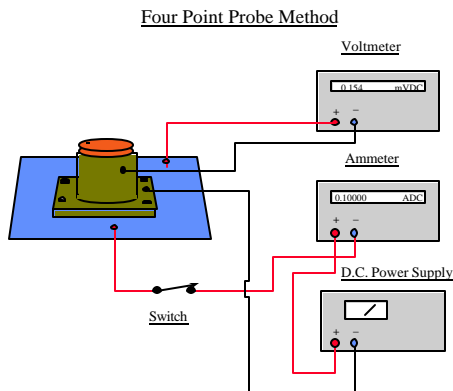
The assemblies were bonded together for 55 days. Electrical resistance was measured daily using the four-point probe test method (figure 6).

Figure 6 Four point probe resistance test

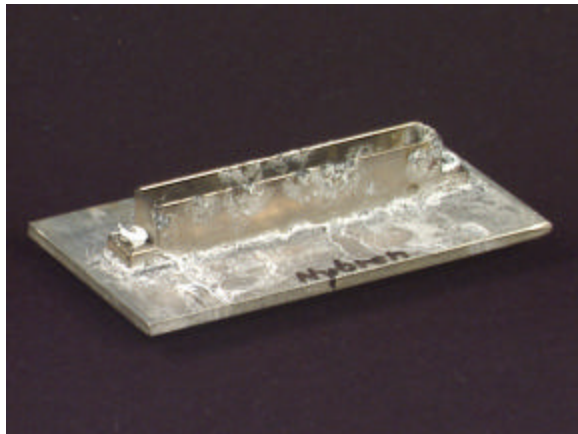
Figure 10 Nybron-plated assembly after salt fog exposure

Resistance values for the AIVD assemblies tested in room ambient conditions were very low initially, and did not increase significantly during the test period. They remained well within the acceptable limit of 2.5 milliohms. Bonding resistance of the IVD aluminum and cadmium-plated samples in the salt fog rose gradually, exceeding 20 and 30 milliohms, respectively, by the end of the test. Bonding resistance of the Nybron®-plated connector assembly climbed very rapidly in the salt fog chamber, exceeding 140 milliohms after 500 hours. The amount of corrosion and deposits increased dramatically on the Nybron® test article. In contrast, the other two assemblies did not show nearly as much of an increase in corrosion products over time (figures 10, 11, and 12).

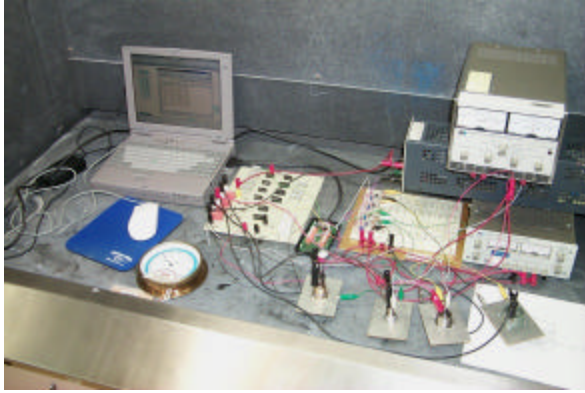
An effort was made to find connector materials which would give good electrical characteristics without the need for platings. Flange-mounted circular connectors made of bronze-aluminum alloy and stainless steel were obtained from the Royal Air Force and J-Tech (Tustin, California), respectively. A jam-nut mounted titanium alloy circular connector was obtained from Allesandro Automatic (Los Angeles, California). Bonding resistance tests were conducted comparing these with conventional cadmium and nickel-plated aluminum alloy connectors. Tests were conducted at room ambient conditions and in a salt-fog environment. Resistance measurements during room ambient tests were acquired with an in-house devised data acquisition system that provided continuous 24-hour sampling and storage without the assistance of an operator (figure 13). This apparatus is shown schematically in figure 14.

Figure 13 Data acquisition and control interface

the 38% RH. Resistance measurements during room ambient tests were acquired with an in-house data acquisition system that provided continuous 24-hour sampling and storage without the intervention of an operator (figure 13).

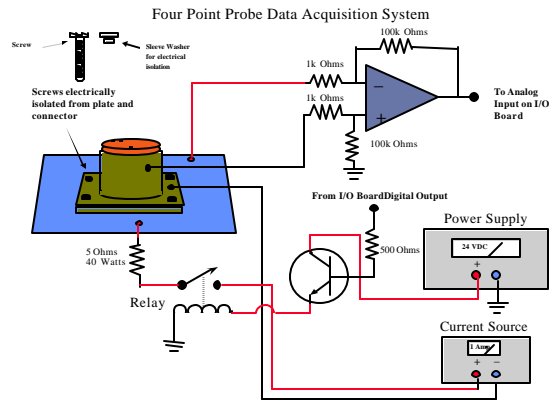
Figure 14 Schematic representation of test fixture

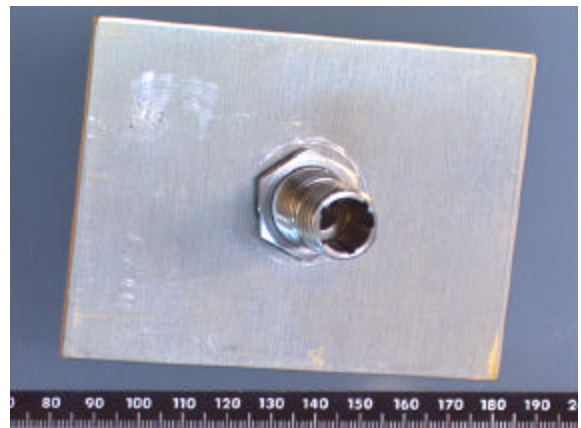
After cleaning, the connectors were mated to aluminum mounting plates which had been conversion coated with alodine chromate conversion coating. The flanged connectors were fastened with stainless steel screws and nuts to the mounting plate (figure 15). The titanium connector was fastened with a jam nut (Figure 16). To prevent the fasteners from contributing to the conductivity of the assemblies, the screws were wrapped with Teflon® tape and fiber washers were used under the nuts. A fiber washer was also used under the jam nut for the titanium connector. The outside surface of the connector was wrapped in Teflon® tape to isolate it from the mounting plate. The screws for the three flanged connectors were torqued to 96 inch-ounces with a torque wrench. The jam nut on the titanium connector was tightened to 30-36 inch-pounds. This is the recommended torque value for a size 9 connector shell. Initial resistance readings were made using a four-point probe measurement system (AEMC Micro-ohmmeter, Model 5600). This test was conducted at room ambient conditions. The temperature and humidity was respectively 72°F and

Figure 16 Titanium alloy connector mounted

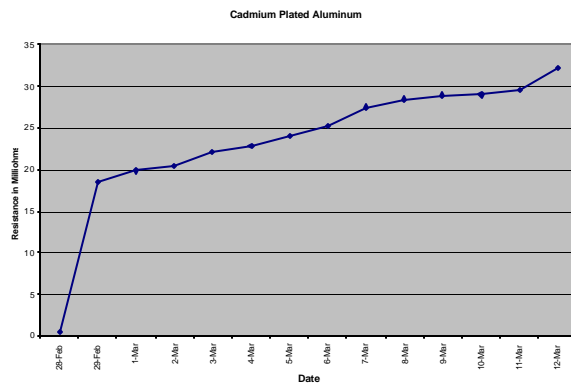
Initial measurements were made by sampling every hour for the first 24 hours. Subsequent measurements were taken every four hours thereafter. Previous experience has shown the bonding resistance changes rapidly in the first 24 hours. Data were acquired continuously for a period of two months. Of the four connector materials tested, only the cadmium-plated aluminum type exceeded the specified resistance limit of 2.5 milliohms during the test (Charts 1 and 2). It failed in the first 24 hours of testing. The remaining three connector assemblies increased slightly in the first 24 hours and then remained nearly constant throughout the test (Chart 3).

Chart 2 Bonding resistance of the cadmium-plated aluminum connector at room ambient conditions

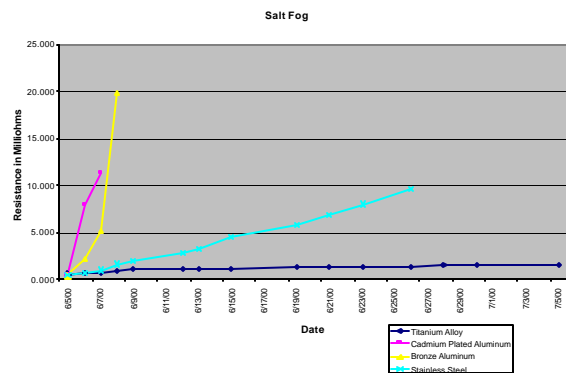
Initially, the connector assemblies were removed from the salt fog environment and tested every 24 hours for the first 4 days. Thereafter, the assemblies were removed from test every two days for measurements. This process was continued for four weeks or until the connector reached a resistance above the failure limit of 2.5 milliohms. Noted during this test was the heavy buildup of white colored deposits around the mating areas between the connector and mounting plate for each of the connector assemblies. Of the four connectors tested, only the titanium alloy connector was able to maintain a resistance value below the 2.5 milliohms failure limit for the four-week period. The cadmium-plated aluminum connector failed in just one day; the bronze-aluminum connector lasted two days, while the stainless steel connector failed after five days (Chart 4).

Chart 4 Bonding resistance of the four connector materials in a salt fog environment
